**Flood Control Project Maintenance
Levee Inspections**

Fall 2008 Levee Maintenance Deficiency Summary Report

Reclamation District No. 0900

Levee Inspection Report By Mile - Fall 2008

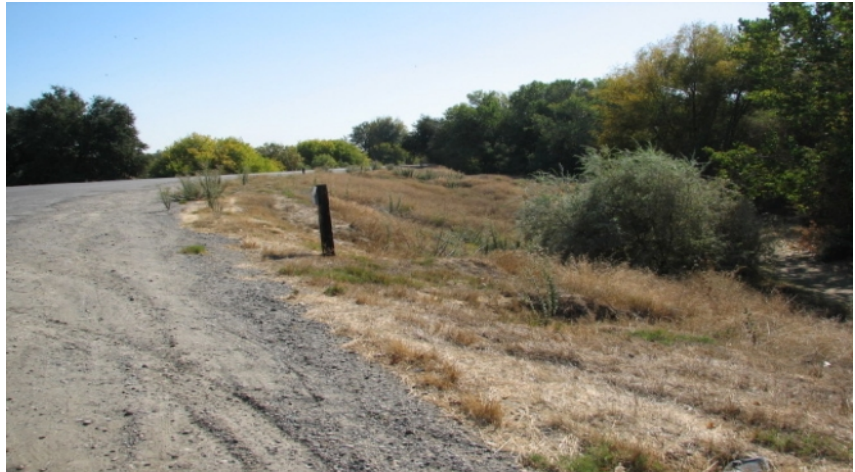
Levee Mile Report Line	1
Start Levee Mile	1.93
End Levee Mile	2.27
Location	
Category	Earthen Levee
Item	Vegetation
Remove/mow wild growth on landside slope within 10' of toe from LM 1.93 to LM 2.27

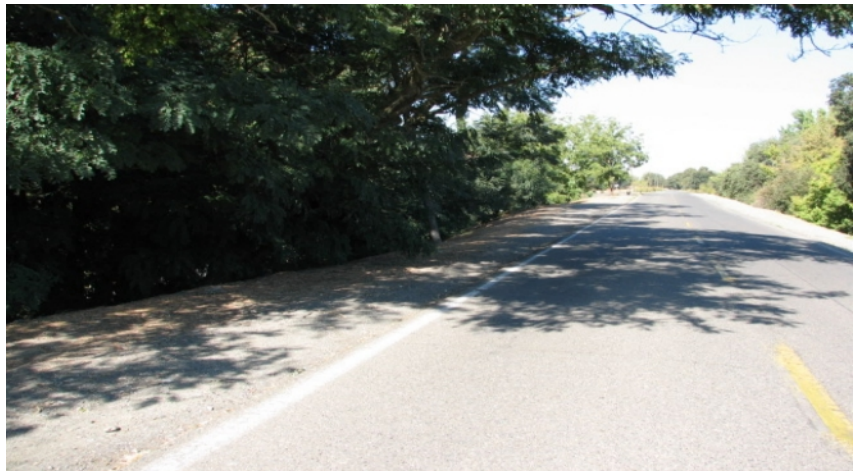
Levee Mile Report Line	12
Start Levee Mile	2.56
End Levee Mile	2.64
Location	
Category	Earthen Levee
Item	Trim / Thin Trees
Trim trees to 5' from surface of levee on landside slope from LM 2.56 to LM 2.64

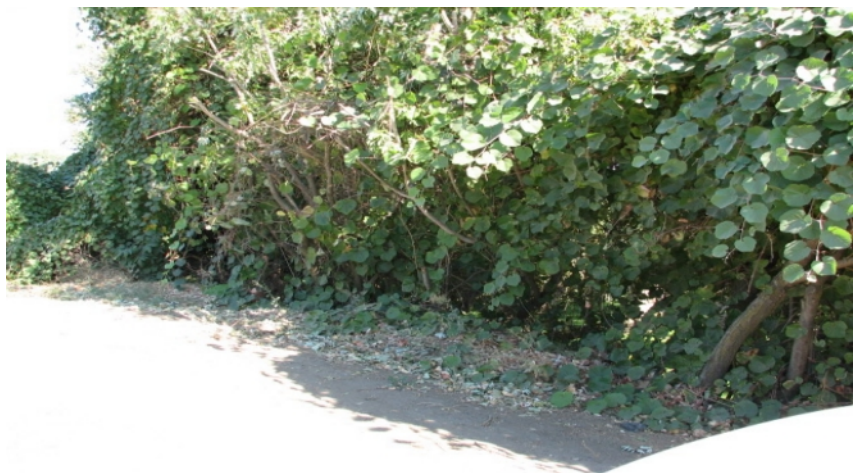
Levee Mile Report Line	25
Start Levee Mile	4.25
End Levee Mile	4.25
Location	
Category	Earthen Levee
Item	Vegetation
Remove wild growth within 20' from shoulder at LM 4.25

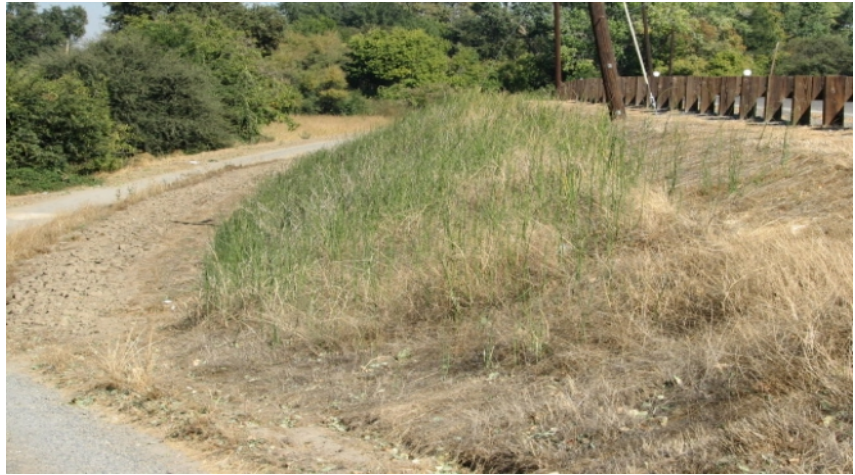
Levee Mile Report Line	26
Start Levee Mile	4.26
End Levee Mile	4.53
Location	
Category	Earthen Levee
Item	Vegetation
Remove/mow wild growth on landside slope within 10' from toe from LM 4.26 to LM 4.53

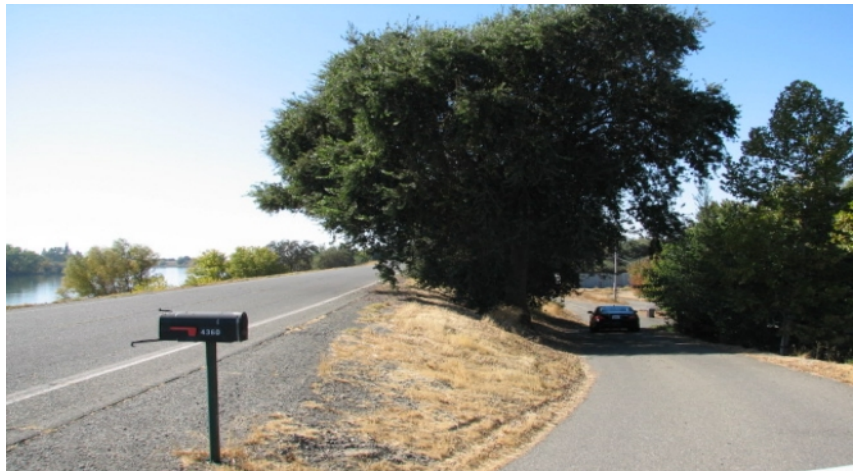
Levee Mile Report Line	41
Start Levee Mile	6.25
End Levee Mile	6.28
Location	
Category	Earthen Levee
Item	Trim / Thin Trees
Trim trees to 5 feet from levee surface LM 6.25-6.28

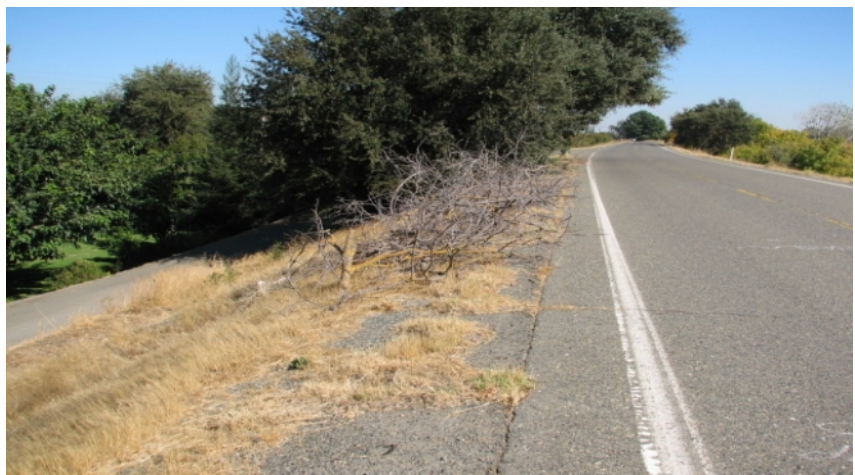
Levee Mile Report Line	42
Start Levee Mile	6.27
End Levee Mile	6.27
Location	
Category	Earthen Levee
Item	Encroachments
Remove prunings on land shoulder at LM 6.27

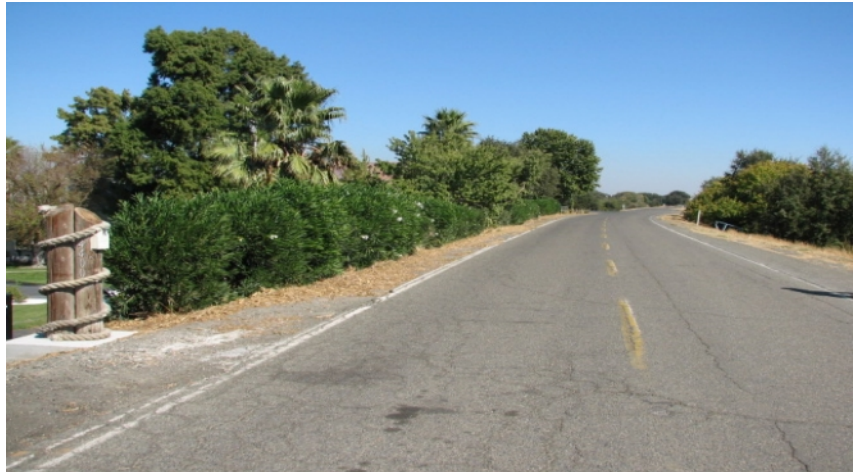
Levee Mile Report Line	44
Start Levee Mile	6.56
End Levee Mile	6.63
Location	
Category	Earthen Levee
Item	Encroachments
Landscape encroachment at LM 6.56 to LM 6.63

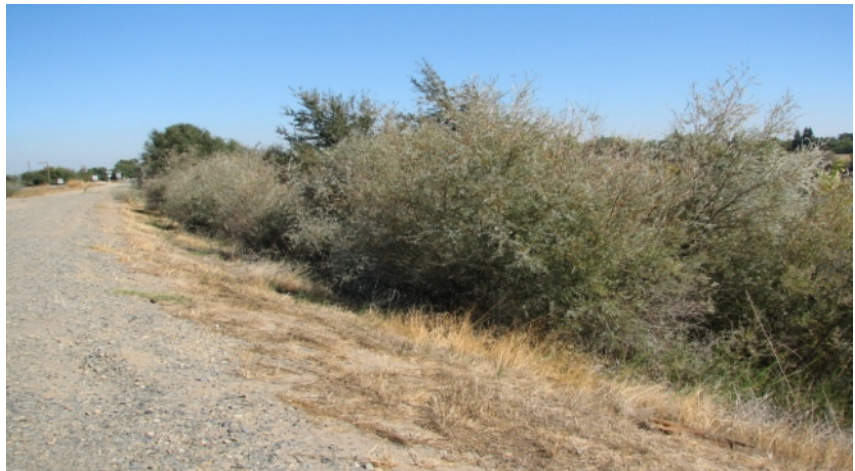
Levee Mile Report Line	52
Start Levee Mile	6.94
End Levee Mile	7.49
Location	
Category	Earthen Levee
Item	Vegetation
Remove wild growth 20' from waterside shoulder from LM 6.94 to LM 7.49

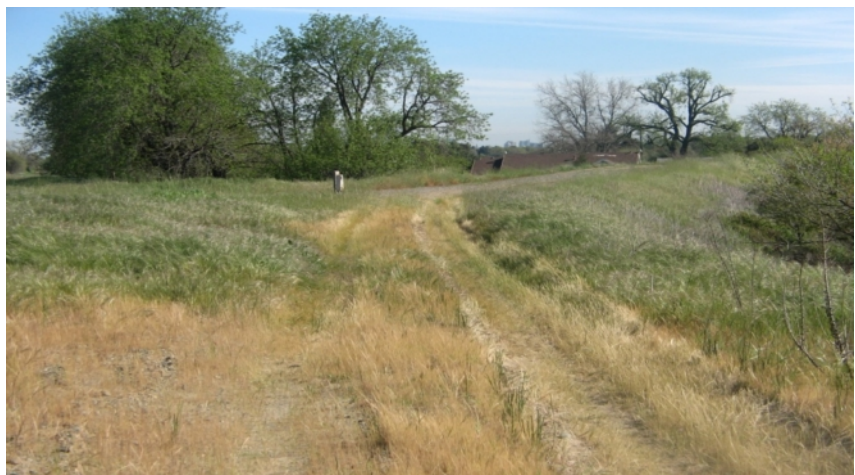
Levee Mile Report Line	55
Start Levee Mile	7.01
End Levee Mile	7.83
Location	
Category	Earthen Levee
Item	Crown Surface / Depressions / Rutting
Crown of levee covered with vegetation from LM 7.00 to 7.83

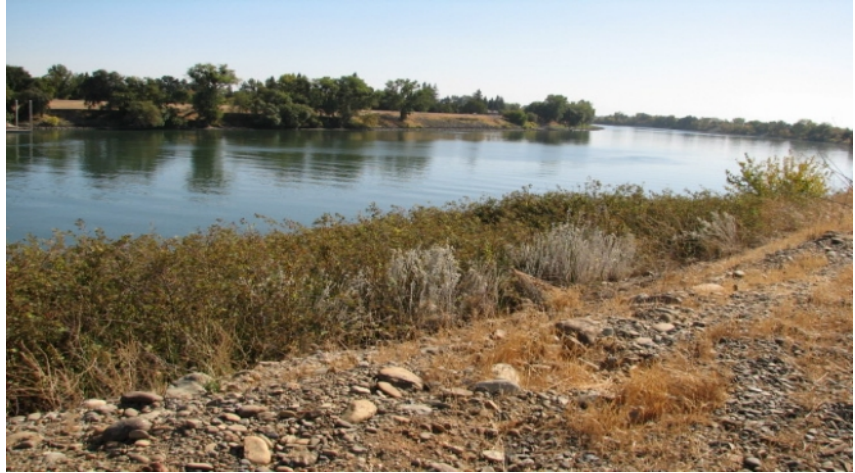
Levee Mile Report Line	66
Start Levee Mile	7.49
End Levee Mile	7.82
Location	
Category	Earthen Levee
Item	Vegetation
Remove/mow wild growth 20' from waterside shoulder at LM 7.49 to LM 7.82

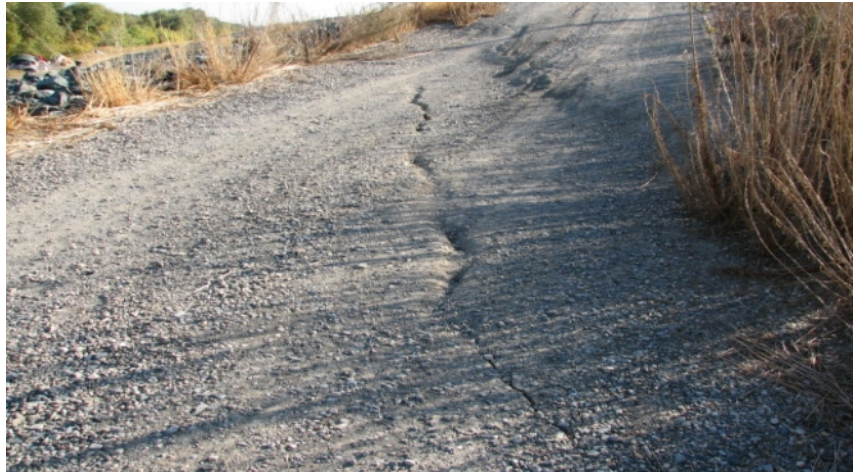
Levee Mile Report Line	2
Start Levee Mile	0.95
End Levee Mile	0.95
Location	
Category	Earthen Levee
Item	Cracking
Crack located on ramp on waterside of levee at LM 0.95.

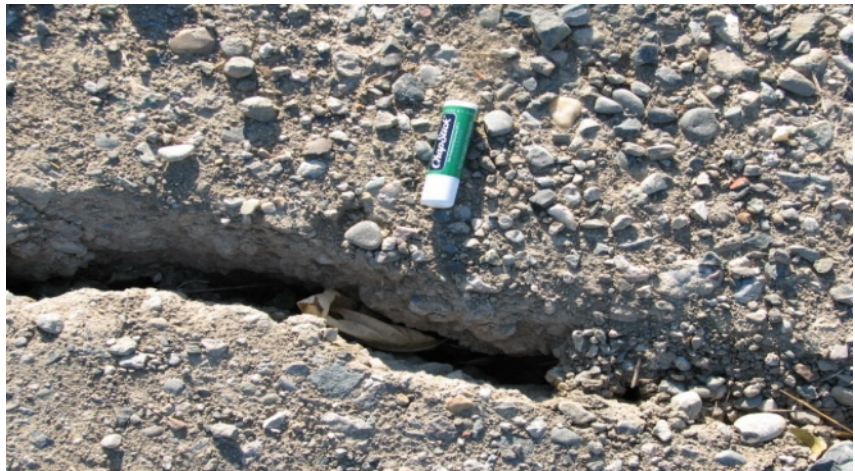
Levee Mile Report Line	2
Start Levee Mile	0.95
End Levee Mile	0.95
Location	
Category	Earthen Levee
Item	Cracking
Closer view of crack at LM 0.95.

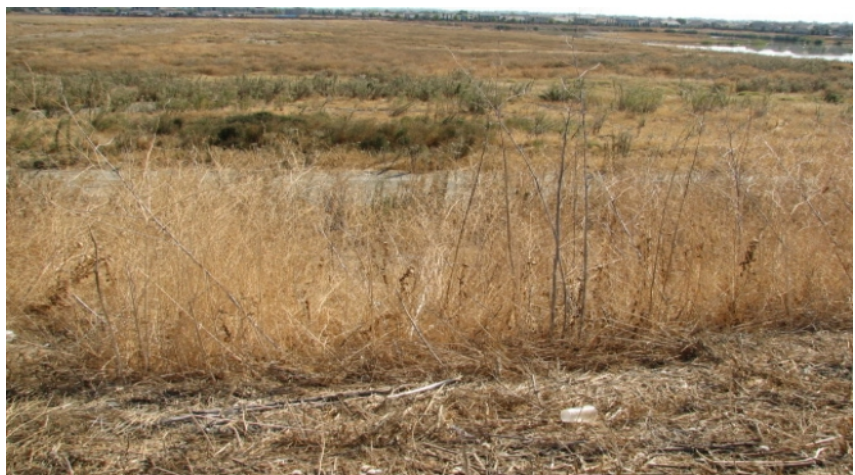
Levee Mile Report Line	3
Start Levee Mile	3.07
End Levee Mile	3.28
Location	
Category	Earthen Levee
Item	Vegetation
Remove/trim brush on landside of levee to 10 feet from the toe from LM 3.07 to LM 4.91.

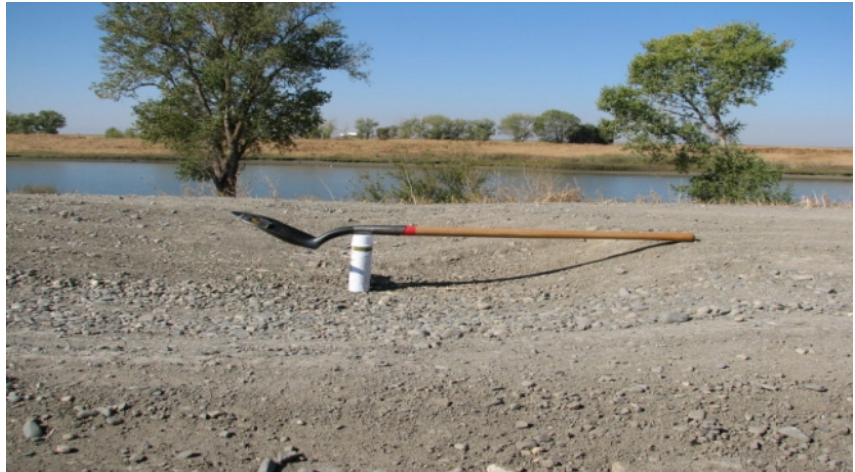
Levee Mile Report Line	4
Start Levee Mile	3.08
End Levee Mile	3.26
Location	
Category	Earthen Levee
Item	Crown Surface / Depressions / Rutting
Multiple, large, deep depressions located in levee crown from LM 3.08 to LM 3.26.

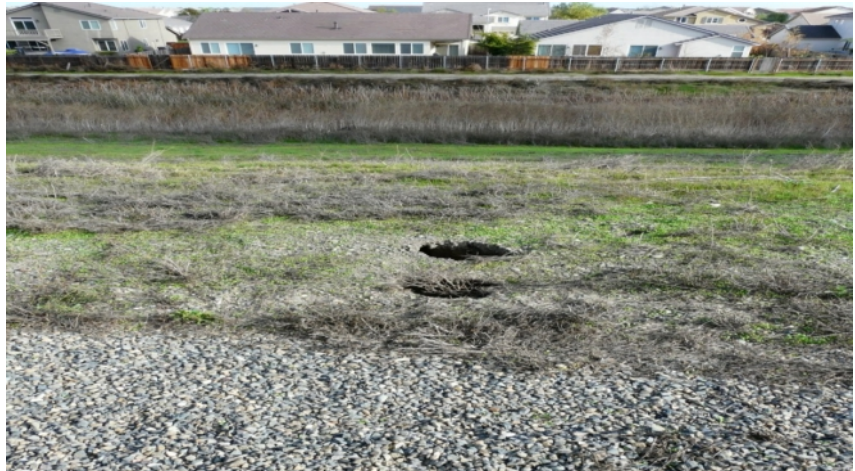
Levee Mile Report Line	5
Start Levee Mile	3.43
End Levee Mile	3.43
Location	
Category	Earthen Levee
Item	Animal Control
Repair damage to levee from rodents at LM 3.43

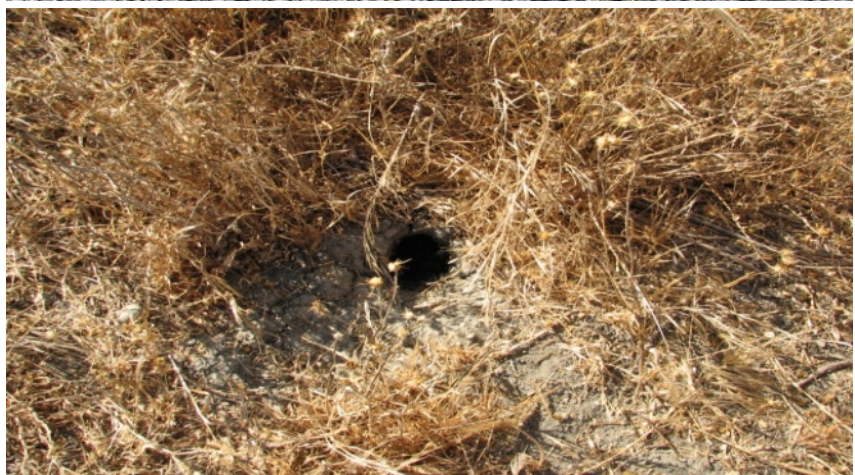
Levee Mile Report Line	6
Start Levee Mile	4.02
End Levee Mile	4.29
Location	
Category	Earthen Levee
Item	Animal Control
Example of rodent burrow on waterside of levee from LM 4.02 to LM 4.29.

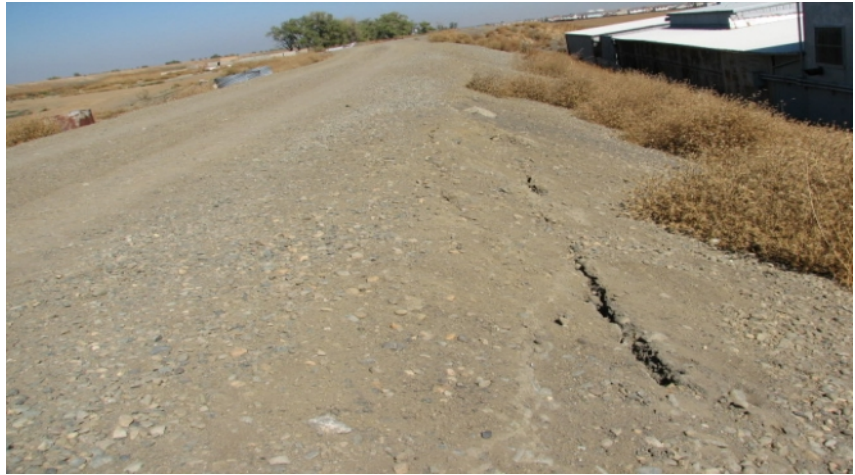
Levee Mile Report Line	8
Start Levee Mile	4.98
End Levee Mile	4.98
Location	
Category	Earthen Levee
Item	Cracking
Crack located on landward shoulder around LM 4.98.

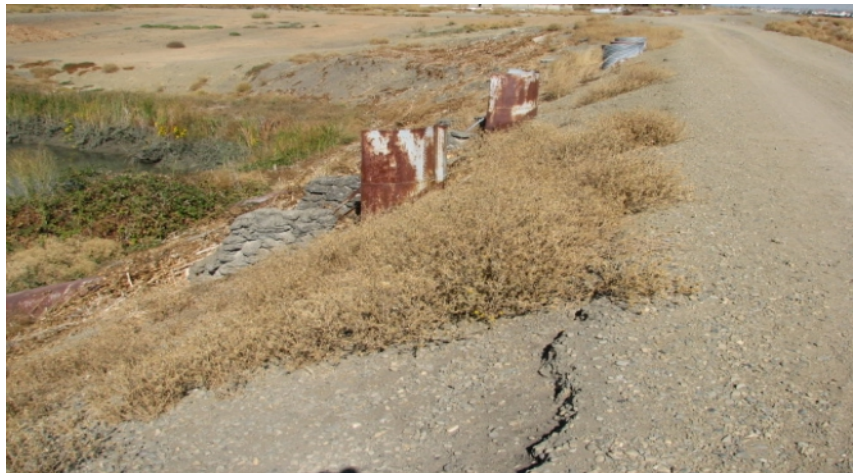
Levee Mile Report Line	8
Start Levee Mile	4.98
End Levee Mile	4.98
Location	
Category	Earthen Levee
Item	Cracking
Crack located on waterward shoulder around LM 4.98.

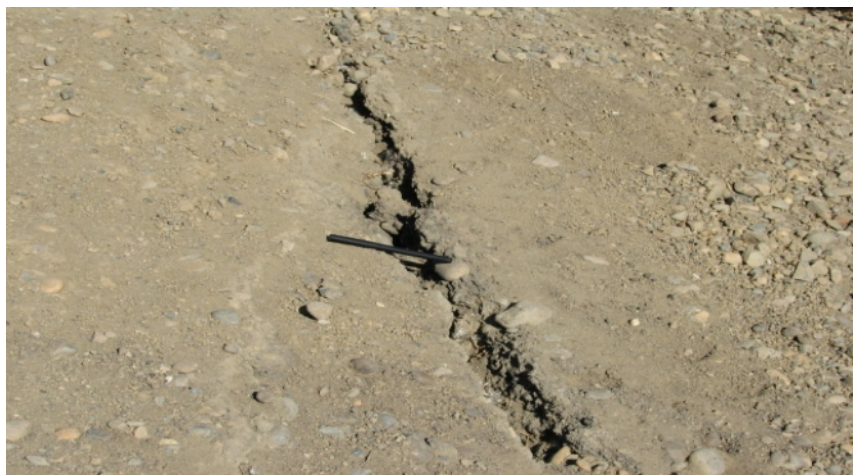
Levee Mile Report Line	8
Start Levee Mile	4.98
End Levee Mile	4.98
Location	
Category	Earthen Levee
Item	Cracking
Closer view of landward crack around LM 4.98; please note black pen for scale.
